TECHNICAL REPORT REMR-CO-3

**CASE HISTORIES OF CORPS BREAKWATER
AND JETTY STRUCTURES**

Report 3

NORTH CENTRAL DIVISION

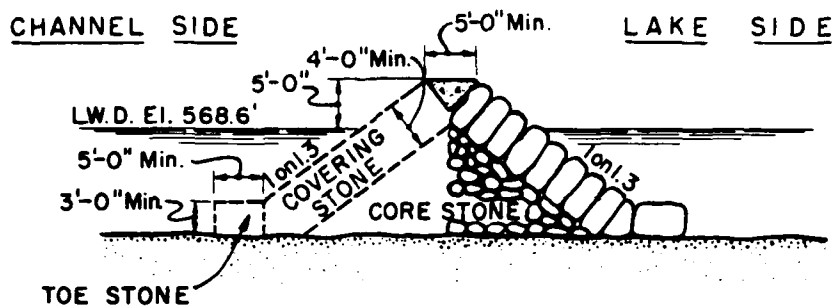
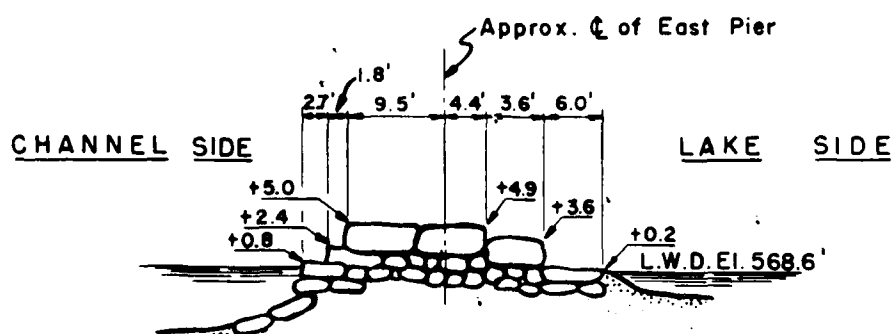
Figure 224. Typical pier cross sections,
Rocky River Harbor, Ohio

Date(s)	Construction and Rehabilitation History
1873	Construction of a 448-ft-long rubble-mound pier (Figure 223, Section B) was completed east of the mouth of the Rocky River. The crest el of the pier was +5.0 ft (Figure 224, Section B).
1941	The existing pier was rebuilt to its original design and extended an additional 452 ft lakeward (Figure 223, Section A). The pier extension was of rubble-mound construction and had a crest width of 5 ft and a crest el of +5 ft lwd (Figure 224, Section A). Side slopes were 1V:1.3H, and armor stones had a minimum weight of 2.5 tons with not less than 40 percent of 4 tons or more.
1970	A total of 260 stones was placed on the pier to repair storm damage.
1981	An inspection of the pier indicated the lakeward portion was in good condition, but the shoreward 390 ft of the pier required rehabilitation. Although no emergency existed at this time, maintenance was recommended to provide full protection to the river entrance and safer access for fishermen onto the pier. It is not known if the repairs were performed. An aerial view of the Rocky River Harbor East pier is shown in Figure 225.

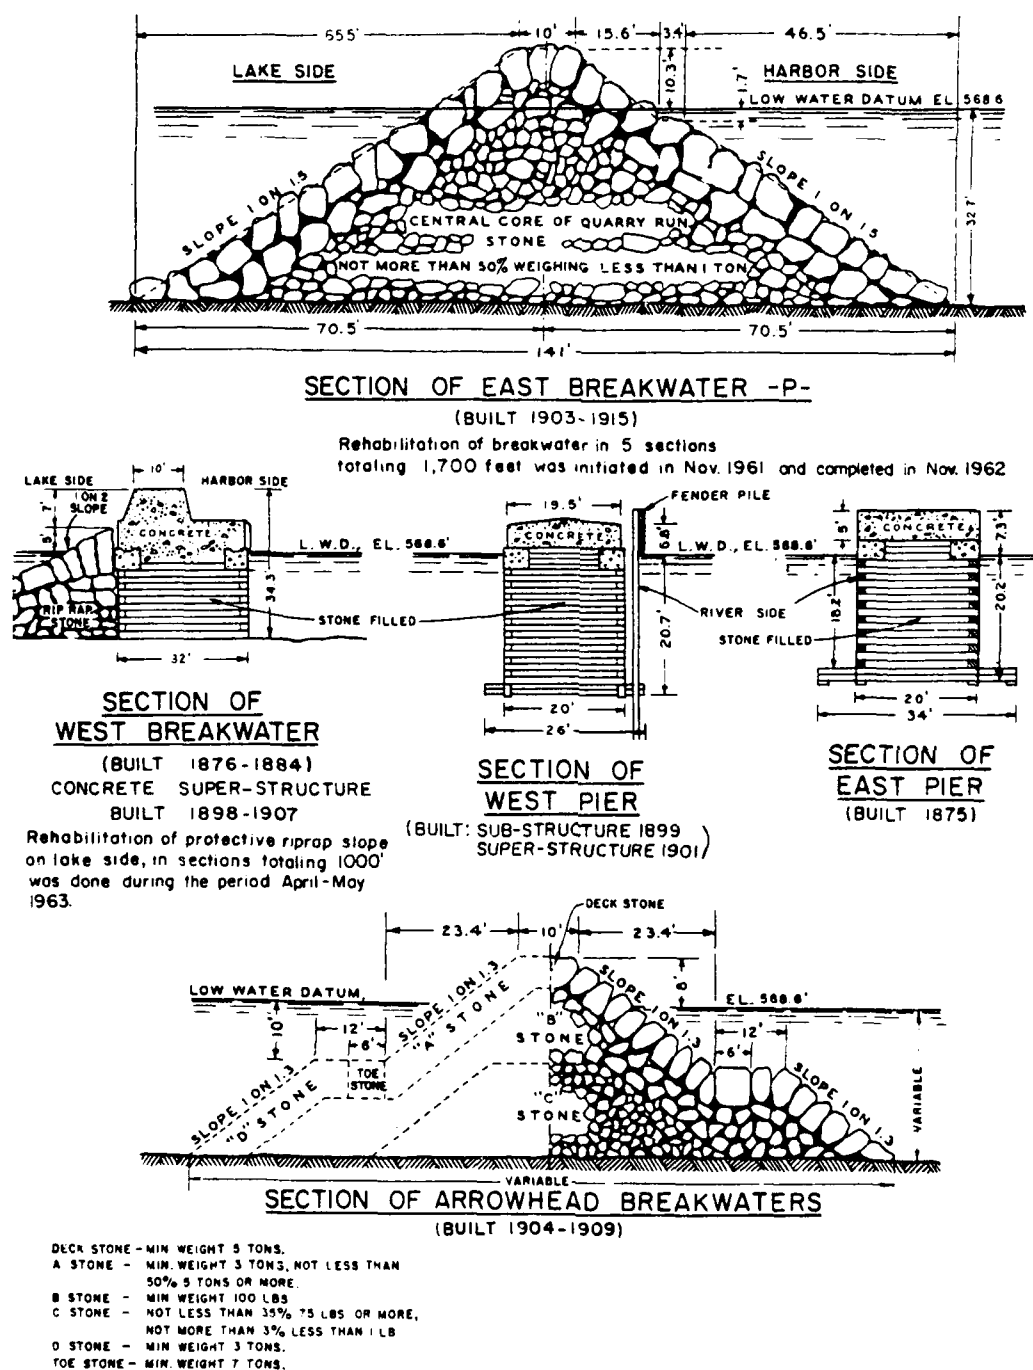
Figure 227. Typical pier and breakwater cross sections, Cleveland Harbor, Ohio

1903- 1915	Construction of a 17,970-ft-long portion of the east breakwater was completed (Figure 226, Sections P and D). The breakwater was a rubble-mound structure with a crest el of +10.3 ft lwd and a crest width of 10 ft (Figure 227, Section P, Figure 229, Section D). Side slopes were 1V:1.5H.
1904- 1909	Construction of the east and west arrowhead breakwaters was completed (Figure 226) at the main entrance. These structures were each 1,250 ft long and constructed of rubble-mound materials. They had crest widths of 10 ft and an el of +8 ft lwd (Figure 227). Side slopes of the arrowheads along the water level were 1V:1.3H. Armor stone had a minimum weight of 3 tons, with not less than 50 percent of 5 tons or more.
1917- 1926	A stone superstructure was installed on portions of the east breakwater (Figure 226, Sections X and Y). The crest el of Section X (Figure 228) was +6 ft lwd. Riprap was also installed along both sides of this portion of the breakwater. The crest el of Section Y (Figure 228) was +10 ft lwd, and stone extended from the el down the lakeside of the structure to the lake bottom.

1961- 1962	Rehabilitation of 1,700 ft of the east breakwater (Figures 226 and 227, Section P) was performed. Original construction methods were used in making the repairs.

Date(s)	Construction and Rehabilitation History
1963	Rehabilitation of 1,000 ft of the protective riprap slope on the lakeside of the west breakwater (Figures 226 and 227) was performed.
1979	Portions of the west breakwater were rehabilitated (Figure 229). The concrete cap was restored to its original height, and new armor stone was installed along the lakeside of the riprap slope. The eastern portion of the east breakwater was in poor condition during a site inspection.
1980	Rehabilitation of 4,400 ft of the eastern end of the east breakwater (Figure 226, Section D) was performed using 29,700 two-ton unreinforced dolos concrete armor units. Two layers of dolosse were placed on the lakeside of the trunk and around the head using a placement density of 161 dolosse per 25 lin ft of breakwater. The slope was 1V:2H. Model tests were not conducted prior to installation of the dolosse.
1982	Repair of the head of the east breakwater following a storm in April was completed using 200 two-ton unreinforced dolosse.

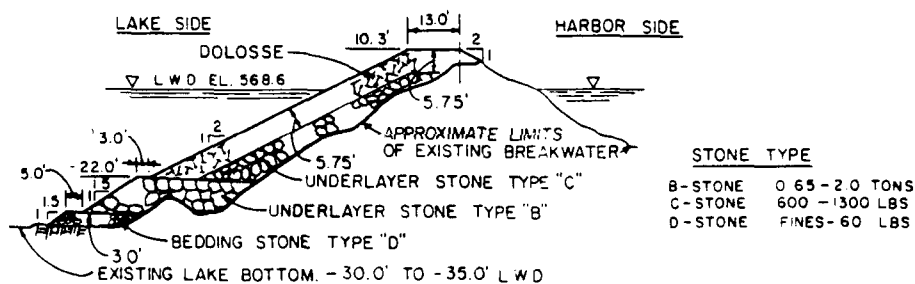
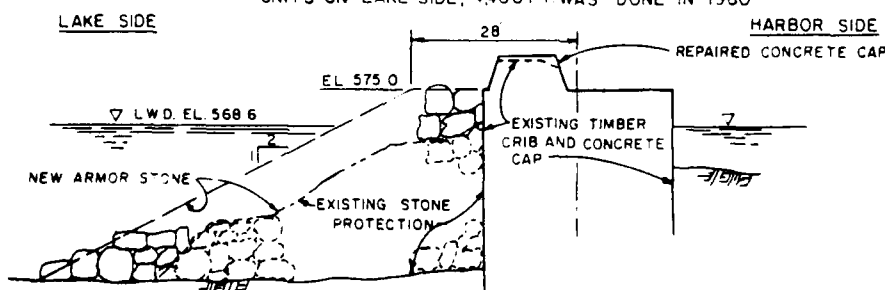
Figure 229. Typical breakwater cross sections,
Cleveland Harbor, Ohio

SECTION OF EAST BREAKWATER-D-
REHABILITATION OF PROTECTIVE CONCRETE ARMOR
UNITS ON LAKE SIDE, 4400 FT WAS DONE IN 1980

SECTION OF WEST BREAKWATER
REHABILITATION OF PROTECTIVE RIPRAP SLOPE AND
CONCRETE CAP
DONE IN 1979

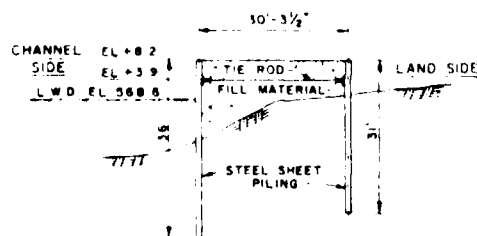
SECTION OF EAST PIER-C
(BUILT IN 1949)

Date(s)	Construction and Rehabilitation History
1949	Because of deterioration of the inner portion of the east pier (Figure 234, Section C) was removed and replaced with steel sheetpiling with a sand fill (Figure 235, Section C). The el of the pier was +8.2 ft lwd.
1972	Settlement of three cell caps in the west breakwater extension led to their replacement with cut stone.
1979	An inspection of the piers and the west breakwater indicated that they were in good to very good condition. Slight settlement of Section J (Figure 234) was noted, however.
1984	Normal maintenance repair of the west breakwater was performed for a cost of \$308,000.
1986	The piers and the west breakwater are considered to be in good condition presently. The east breakwater is in a state of deterioration throughout its entire length. At several places the slope stone has disintegrated and settled; and the core stone has washed out, leaving large areas of the structure only slightly above lwd. Since proposed industrial expansion in the lee of the east breakwater never materialized, the structure has not been maintained. An aerial view of the Fairport Harbor structures at the entrance is shown in Figure 237.

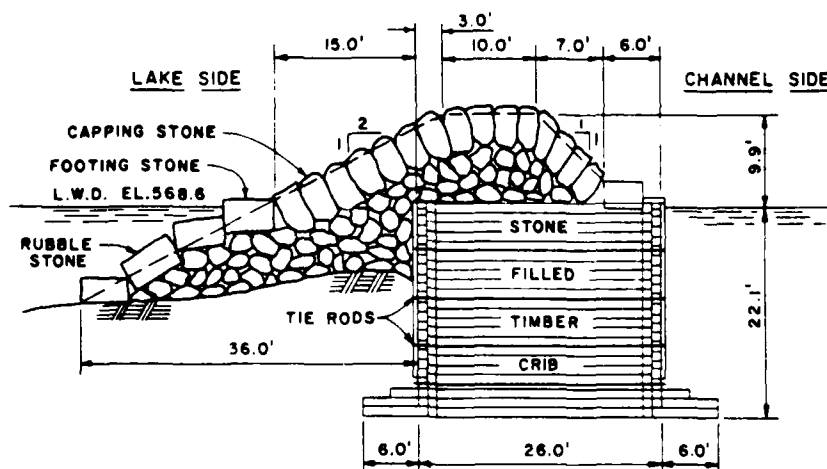
**SECTION OF
WEST BREAKWATER-J**
(BUILT 1905)
(REPAIRED 1925)

1925	Stone was placed over the cap and on the lakeside of the timber crib portion of the west breakwater (Figures 234 and 236, Section J). The stone was placed at an el of +9.9 ft lwd with a crest width of 10 ft and side slopes of 1V:2H.
1932	Construction of a 6,750-ft-long rubble-mound detached east breakwater (Figure 234, Section B) was completed. The breakwater had a crest el of +8.2 ft lwd and a width of 10 ft (Figure 235, Section B). Side slopes were 1V:1.5H and had a minimum weight of 3 tons.
1935	A 500-ft-long extension of the west breakwater (Figure 234, Section F) was completed. The extension consisted of a sand-filled cellular steel sheet-pile structure (Figure 235, Section F). The cells were 30 ft in diameter and capped with concrete at an el of +8.4 ft lwd. Riprap was placed on the channel side.
1939	Construction of a 500-ft-long west pier (Figure 234, Section D) was completed. The pier consisted of sand-filled cellular steel sheet-pile structures (Figure 235, Section D). The cell diameters were 34 ft, and they were capped with concrete at an el of +7.9 ft lwd.

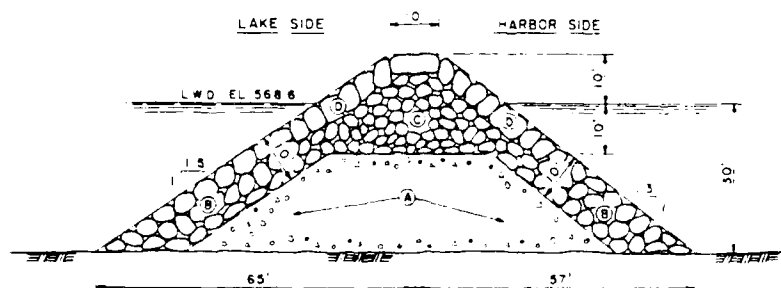
**SECTION OF EAST AND WEST
BREAKWATERS-A-B**

REHABILITATION OF 600' INITIATED IN
MAY 1963 AND COMPLETED IN JUNE 1964

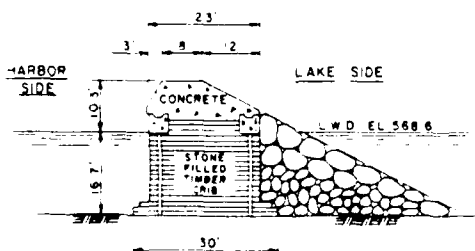
**SECTION OF
EAST BREAKWATER-C**

REHABILITATION OF 1000 FEET INITIATED IN APRIL
1963 AND COMPLETED IN OCTOBER 1963

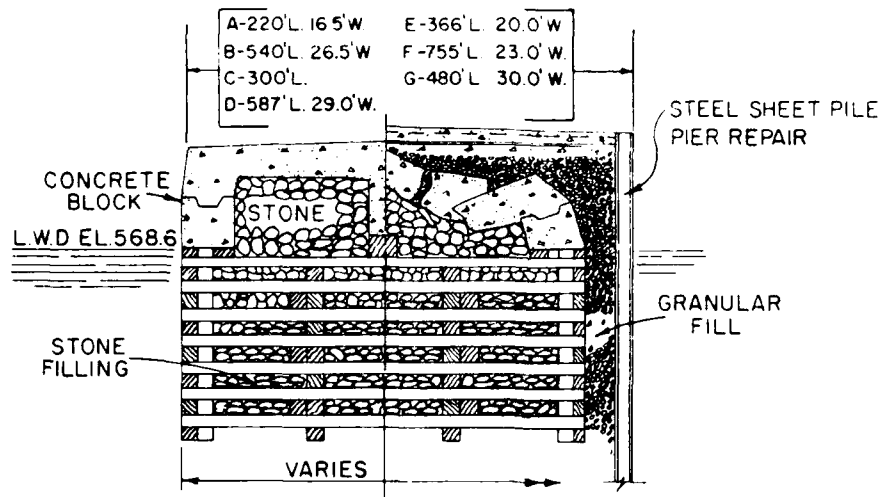
SECTION OF NORTH PIER

(BUILT 1825 - 1900 SUPERSTRUCTURE 1903 - 1909)
(REBUILT 1141 FEET OF SUPERSTRUCTURE 1953 - 1956)

A-REPAIRED IN 1953-1954
D-REPAIRED IN 1954-1955

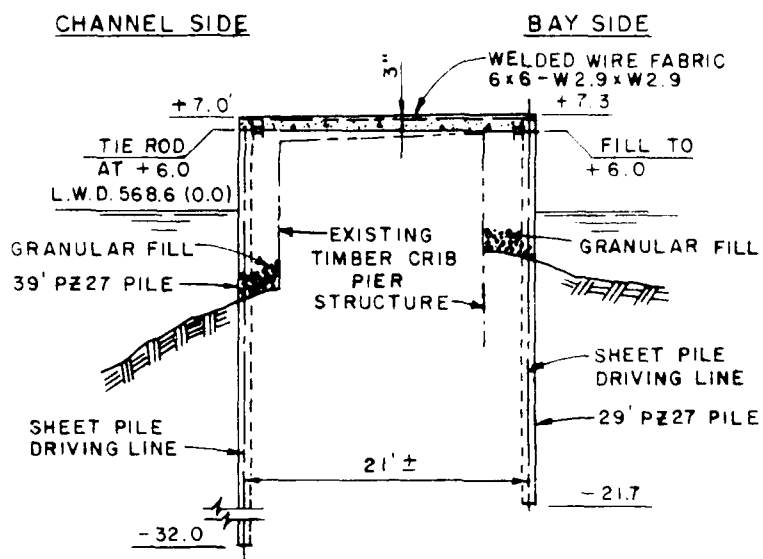
SECTION OF NORTH PIER-A

1979	A disposal dike was constructed adjacent to the south pier (Figure 253).
1984	Portions of the north pier were repaired (Figure 253, Sections A, F, and G). These piers were encased in steel sheetpiling. The voids between the sheetpiling and the existing timber cribs were granular filled, and the structure was recapped with concrete (Figure 255). The shoreward end of the north pier (Section A) was approximately 21 ft in width with a crest el of +7.3 ft lwd. The lakeward portions of the pier (Section F and G) were about 28 ft wide with an el of +9.8 ft lwd.
1986	The piers are presently considered to be in good condition. An aerial photo of the Erie Harbor piers prior to the construction of the disposal dike is shown in Figure 256.

REPAIRED 1984

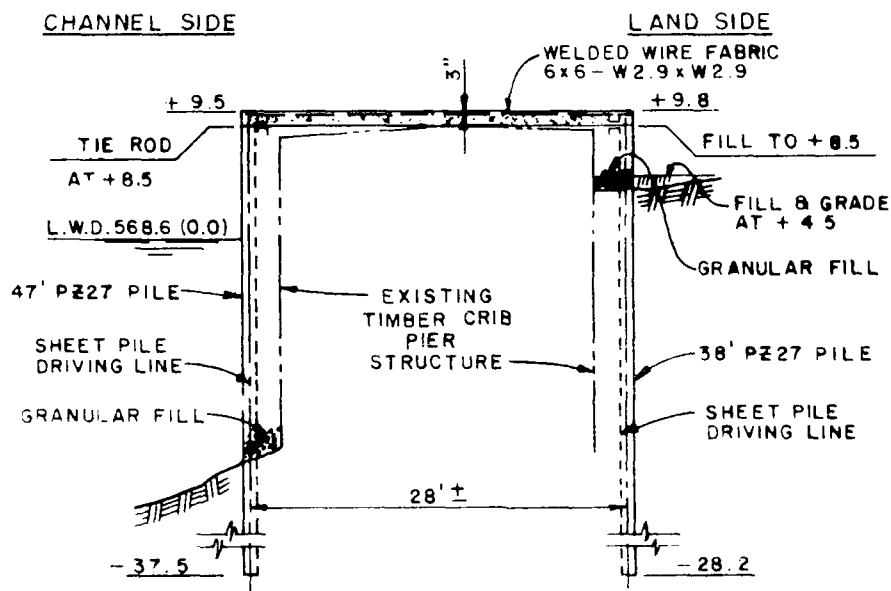
Figure 255. Typical north pier cross sections,
Erie Harbor, Pennsylvania

SECTION OF NORTH PIER-F-G

REPAIRED 1984

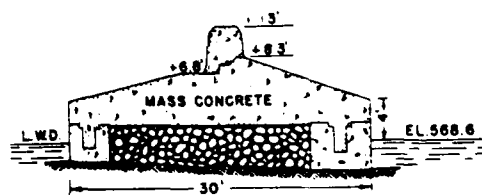
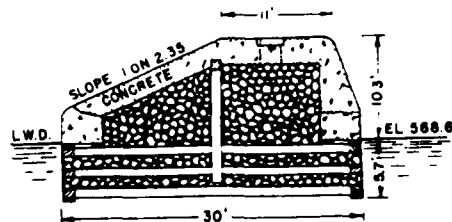
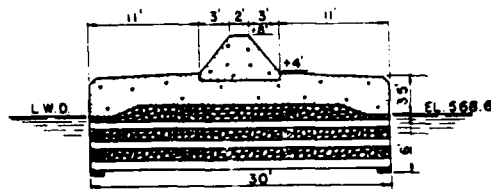
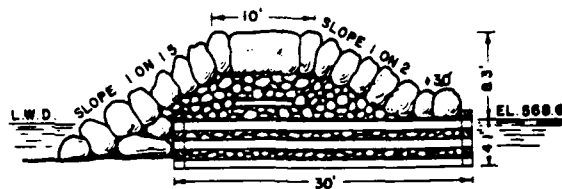
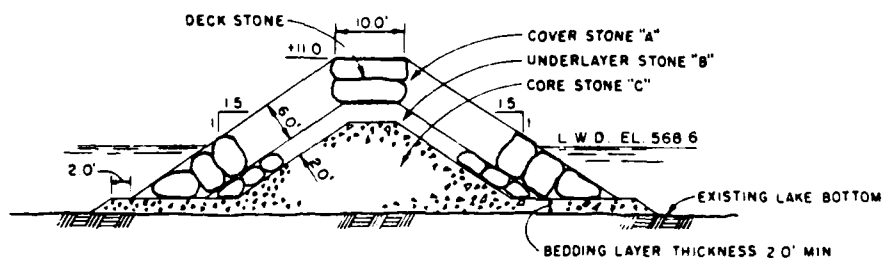
Figure 260. Typical structure cross sections, Dunkirk Harbor, New York

1986	The inner rubble-mound breakwaters presently are in good condition, and the west pier and outer breakwater are considered to be in fair condition. The concrete portions of the superstructure of the outer breakwater and pier show signs of spalling and slight separation at the joints; however, no immediate action is required. The stone superstructure portions of the outer breakwater seem to have settled lakeward in areas, and additional stone has been recommended to increase the height of the structure to its original design. An aerial view of the Dunkirk Harbor structures is shown in Figure 261.

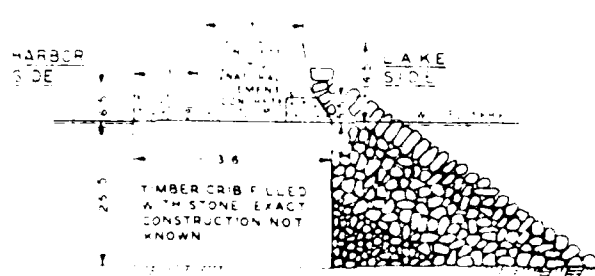
SECTION OF OLD BREAKWATER - C -
BUILT SUPER-STRUCTURE 1889'

Rehabilitation of port was of Section commenced on 24 May, 1944. The barrier, 451 feet in the bridge water, north, of the North Entrance Channel, and a 200 foot section about 320 feet south, of the North Entrance Channel were repaired and a 110 ton pile cap on the harbor, de was placed. Rehab. ition was completed on 31 August 1945.

Date(s)	Construction and Rehabilitation History
	a crest el of +12 ft lwd with slopes of 1V:1H on the harbor side and 1V:1.5H on the lakeside.
1930- 1934	Major repairs were performed on portions of the Old Breakwater (Figures 265 and 266, Section C). Portions of the concrete superstructure were replaced, and a protective stone slope was installed on the lakeside of the structure.
1936	A 2,000-ft-long south entrance arm breakwater (Figure 265, Section J) was constructed. The structure was built with rubble-mound materials and had a +14.2 ft lwd crest el with a 10-ft width. Slopes on the harbor side were 1V:1.3 and 1V:1.5H, and slopes on the lakeside were 1V:1.5H. Armor stone weight was 3 tons (min), with not less than 50 percent being 5 tons or more.
1959- 1962	A portion of the Old Breakwater was removed, resulting in a 982-ft gap for a new entrance channel (Figure 265). A 1,800-ft-long rubble-mound west breakwater (Figure 265) with a concrete cap was constructed to provide wave protection to the new entrance. The breakwater had a crest el of +12.2 ft with a width of 8 ft. Side slopes were 1V:1.3H on the harbor side and 1V:1.5H on the lakeside. Armor stone was 7 tons (min) each. These modifications were model tested prior to construction (Hudson, Housley, and Wilson 1960).

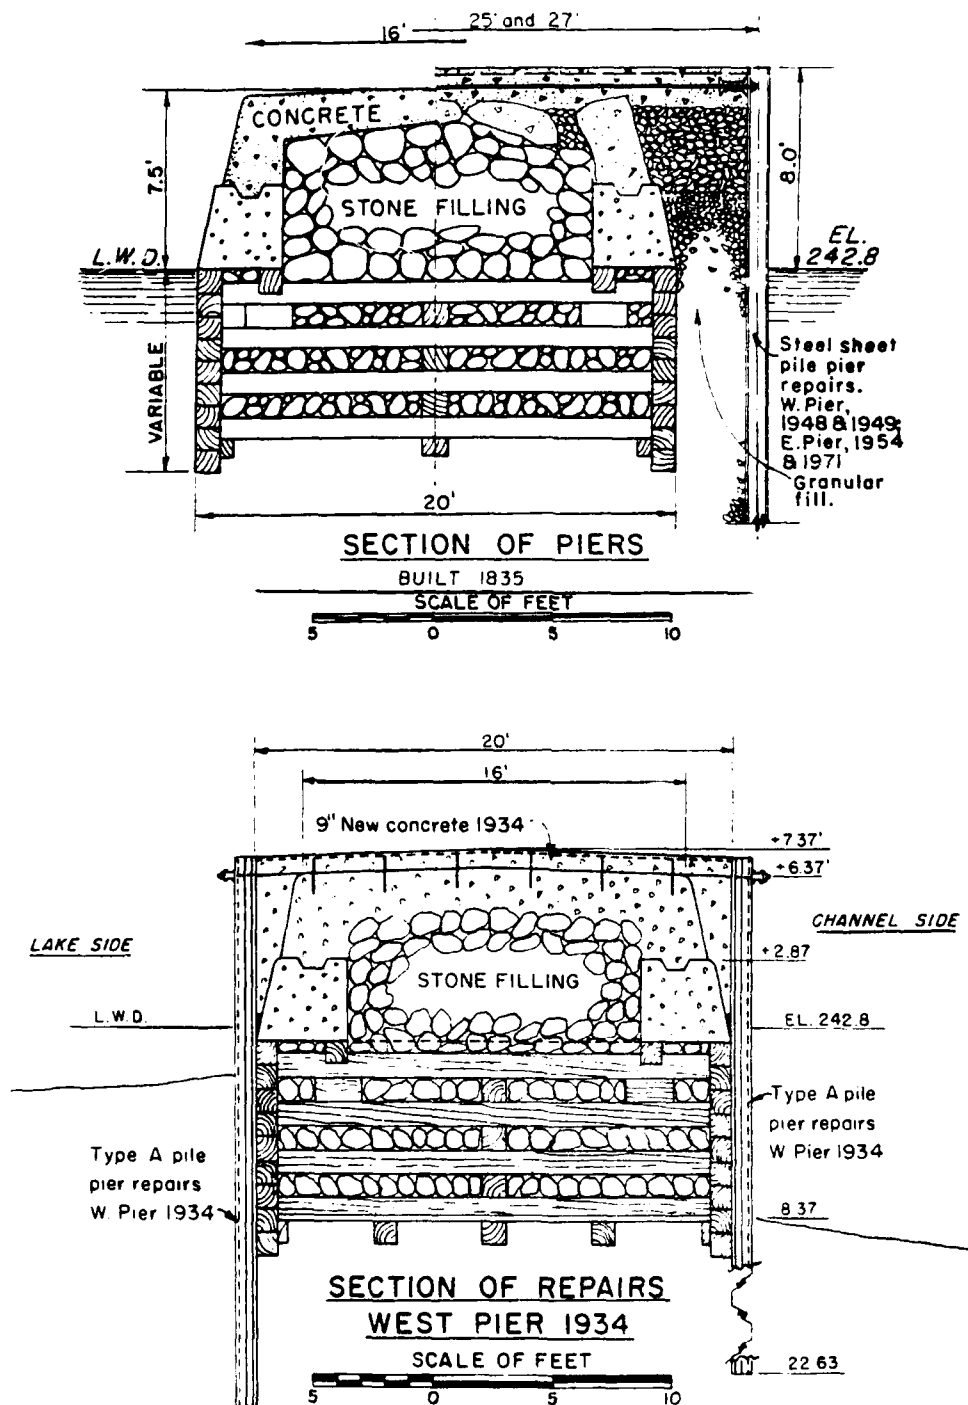
Figure 282. Typical pier cross sections, Rochester Harbor, New York

1954	Rehabilitation of the lakeward 551-ft-long portion of the east pier was completed (Figure 281). The repairs were similar to those of the west pier completed during 1948-49 (Figure 282).
1971	Additional rehabilitation of the 706 ft of the east pier was completed (Figure 281). Repair methods consisted of parallel steel sheetpiling, granular fill, and a concrete cap, similar to that done previously (Figure 282).
1980- 1981	Rehabilitation of a 410-ft-long portion (Figure 281) of the west pier was completed. Repairs consisted of the installation of parallel steel sheet-pile walls (on each side of the existing structure). Voids were granular filled, and the pier was capped with concrete. The crest el of the repaired structure was +7.5 ft lwd, and the pier width was 22 ft.
1983- 1984	A 1,125-ft-long portion of the west pier (Figure 281) was rehabilitated. Repairs were similar to those done previously by encasing the existing structure in steel sheetpiling, filling the voids with granular fill, and capping the structure with concrete.

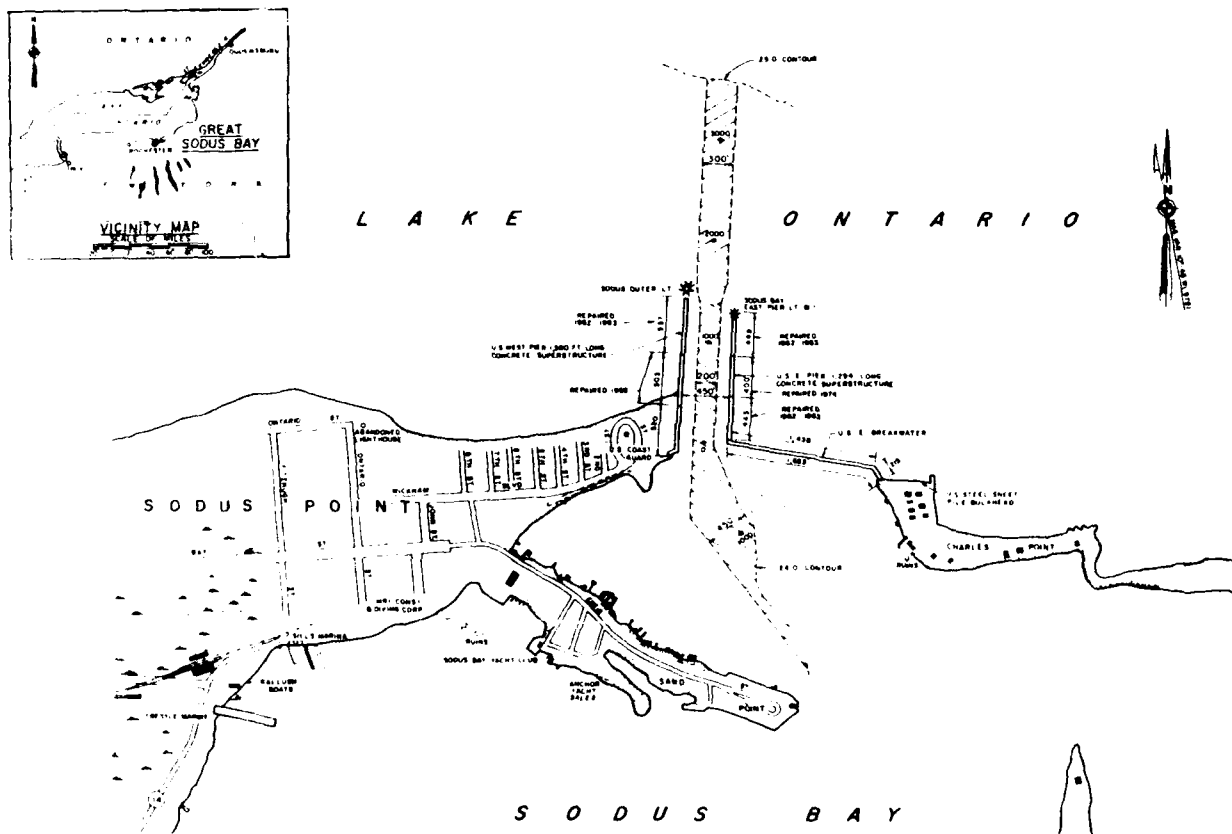
Figure 287. Great Sodus Bay Harbor, New York

1958	A 503-ft-long portion of the west pier was repaired (Figure 287). The existing pier was encased with steel sheetpiling driven 27 ft apart. Voids were granular-filled, and the pier section was capped with concrete (Figure 288). The el of this portion of the pier was +8.7 ft lwd.
1962- 1963	A 557-ft-long portion of the west pier and two portions (445 and 449 ft) of the east pier (Figure 287) were rehabilitated. Repairs were similar to those done on the west pier in 1958 (Figure 288). The els of these pier portions were +8.8 ft lwd.
1974	Rehabilitation of the remaining 400-ft section of the east pier (Figures 287 and 288) was completed. Repairs included two sheet-pile walls, granular fill, and a concrete superstructure (similar to previous rehabilitation of the structure). Repairs to the west pier, also performed during this year, consisted of the placement of riprap stone on the lakeside of the structure. The stone ranged in weight from 400 lb to 2 tons and extended to the lwd el.

1976	A 400-ft-long section of the east breakwater (immediately east of the east pier) was repaired using stone fill and recapping the structure with concrete. Stone was also placed on the lakeside of the breakwater in this location.
1978	Repairs to the west pier were performed which included placing fill stone in portions of the pier and capping the structure with concrete. Riprap was also placed along the channel side of the pier. Riprap stone ranged in weight from 250 to 500 lb.

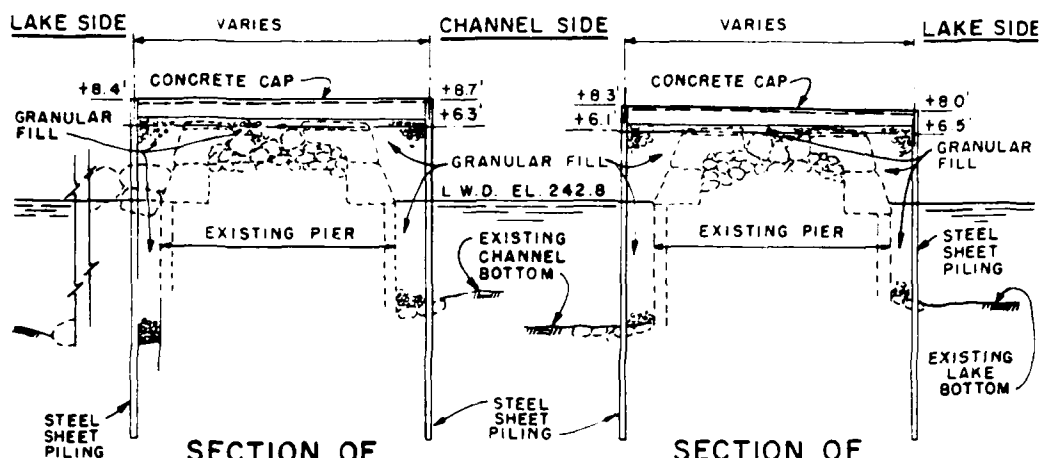
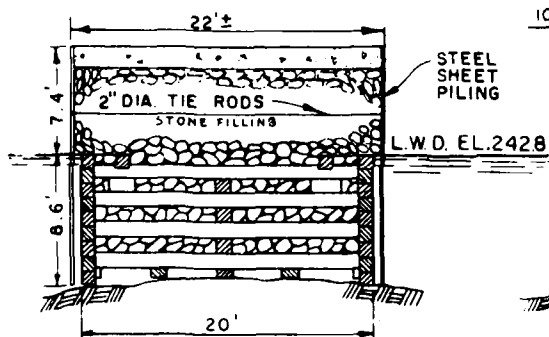
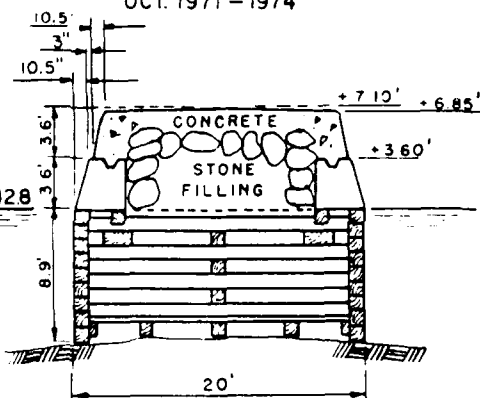
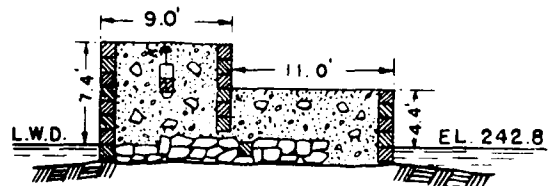
Figure 291. Typical structure cross sections,
Little Sodus Bay Harbor, New York

1967	Repairs to 300 ft of the east pier and 1,127 ft of the west pier (Figure 290) were completed. They included encasing the existing structures with steel sheet-pile walls, filling the voids between the new sheetpiling and the existing pier with granular fill, and capping the structure with concrete (Figure 291). The crest el of the east pier was +8.3 ft lwd, and the west structure had an el of +8.7 ft lwd.
1971- 1972	Rehabilitation of another 626 ft of the east pier (Figure 290) was completed. Repairs were similar to those completed in 1967 (Figure 291).
1974	Remaining portions of the east pier (those not rehabilitated at an earlier date) were repaired (Figure 290). Rehabilitation consisted of similar construction methods used in earlier repairs which included steel sheet-pile walls, granular fill, and concrete caps (Figure 291).
1978	Repairs to the shoreward 620-ft-long portion of the west pier were completed (Figure 290). Rehabilitation consisted of encasing the existing pier with steel sheet-pile walls, installing granular fill in the voids between the new walls and the old timber crib, and pouring a concrete cap.

1986	During their lifetime the entire east and west piers have been rehabilitated. There is no record of repairs to the west breakwater; however, the concrete cap is currently spalled and cracked in many locations. Presently the structures are considered to be in fair condition.

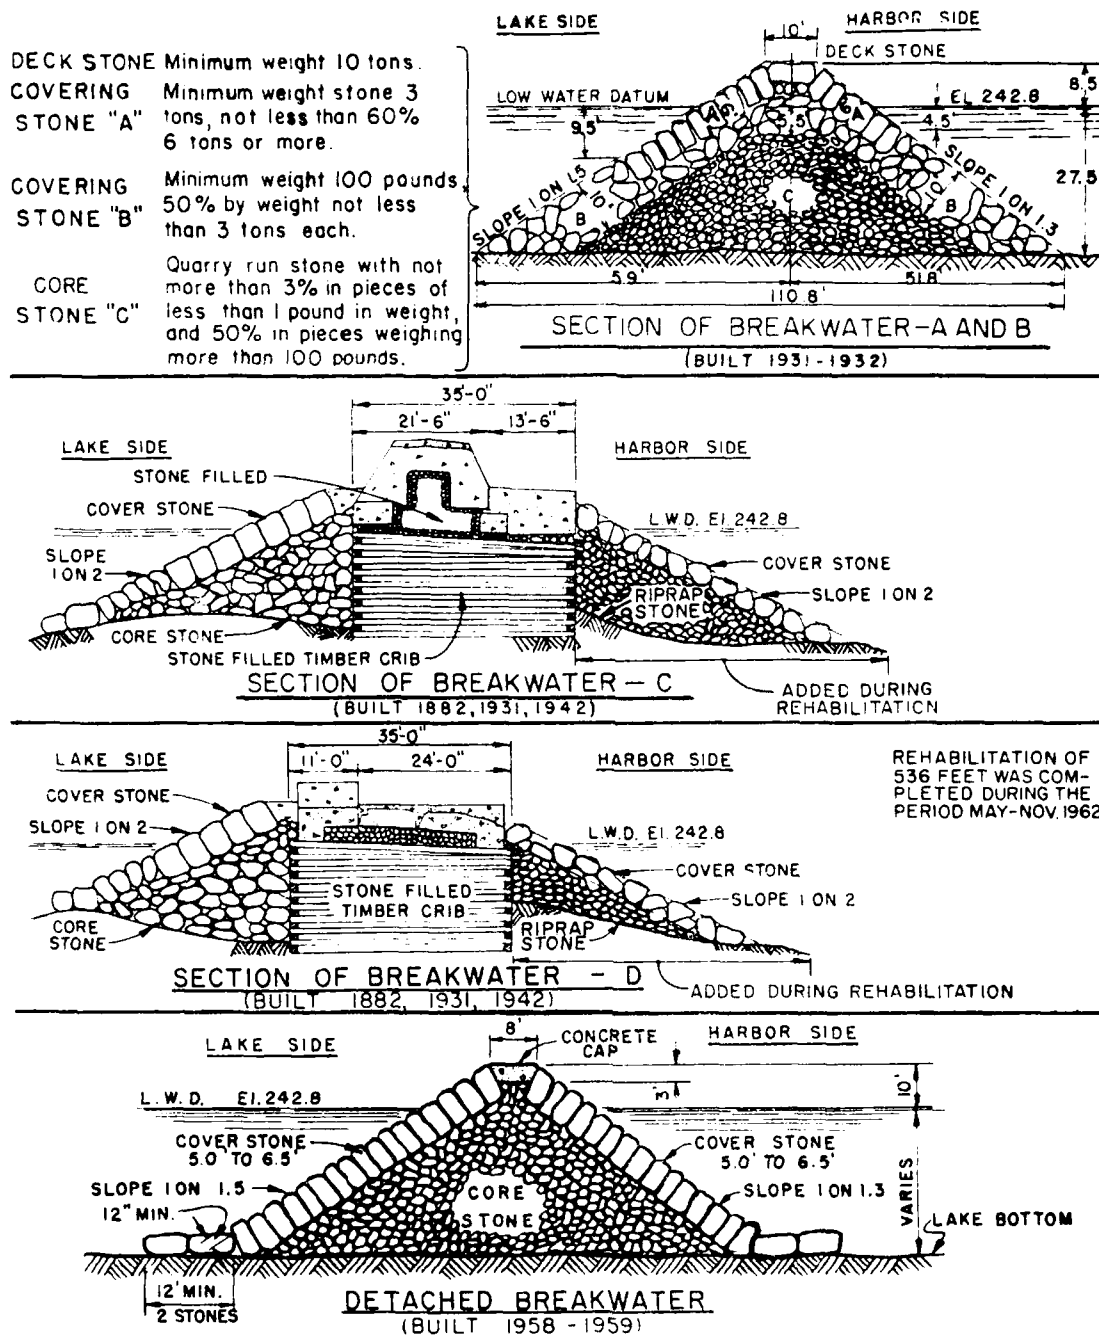
Figure 293. Typical breakwater cross sections, Oswego Harbor, New York

1958- 1959	Construction of an 850-ft-long detached rubble-mound breakwater (Figure 292) was completed. The crest el of the structure was +10 ft lwd, and its width was 8 ft. Slopes on the lakeside were 1V:1.5H, and on the harbor side they were 1V:1.3H (Figure 293). Cover stones weighed 7 tons each. This breakwater was model tested prior to construction (Fortson et al 1949).
1962	Rehabilitation of the west breakwater (Figures 292 and 293, Sections C and D) was completed. Repairs consisted of replacement of lost stone on the lake slope, placement of riprap stone on the harbor side, and replacement of portions on the concrete superstructure (over cracked and displaced sections). The weight of the cover stone used on the harbor side ranged from 1 to 3 tons.
1983- 1984	Rehabilitation of the breakwaters was performed. The timber crib structure was replenished with stone fill, and the concrete cap was repaired in various areas. Riprap on the lakeside and harbor side was replaced as needed. Missing armor stones on the rubble-mound sections of the breakwater were replaced as needed.

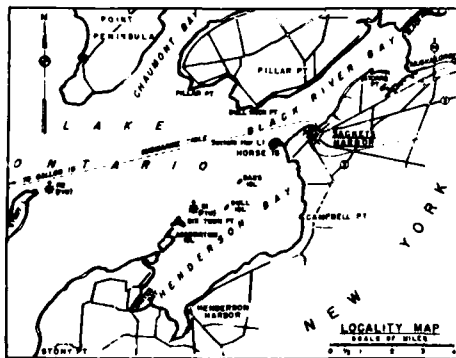
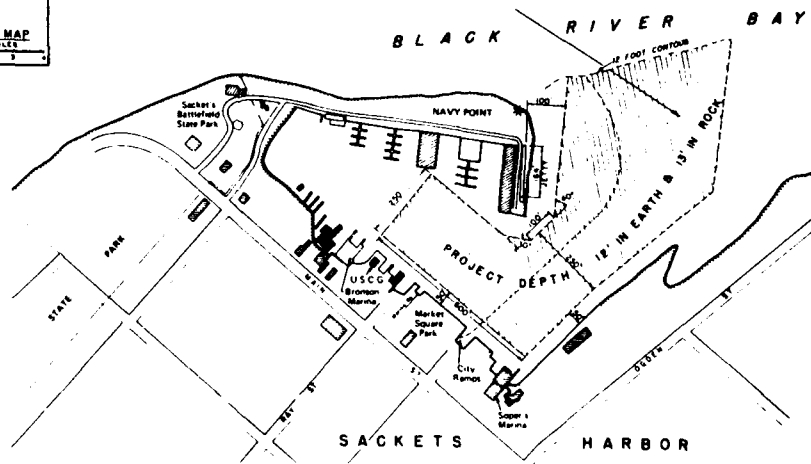
Figure 295. Sackets Harbor, New York

Date(s)	Construction and Rehabilitation History
1888	Construction of a 164-ft-long jetty (Figure 295) was completed. The jetty consisted of stone and wood piles and had an el of +4.0 ft lwd and a width of about 11 ft (Figure 295).
1986	There are no records of repairs to the jetty, and it appears the shoreline has progressed beyond the jetty yielding it nonfunctional.
